# **STREAM RESTORATION IMPACTS ON AND POST- RESTORATION ADJUSTMENT OF GEOMORPHOLOGY, GEOMORPHIC COMPLEXITY & HYDRAULICS**

## **Hydromorphological monitoring of ReBorN LIFE Project**

March 2022

Department of Ecology & Environmental Science

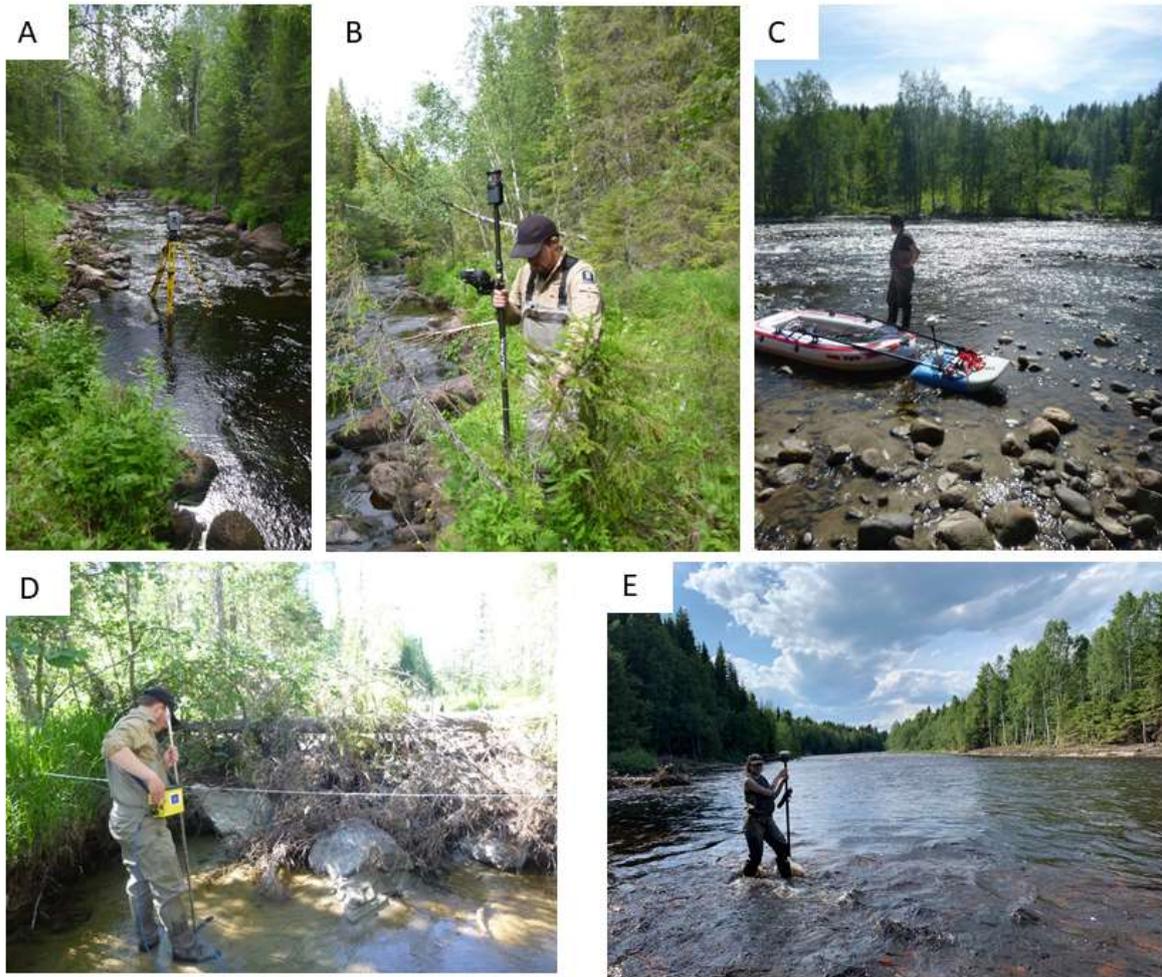
Figure 2. Field photos of methods: (a) & (b): Total station and pole with prism used to take points (both photos from site LTA2 in 2018); (c) ADCP setup used in LMB2 in 2018; (d) velocity measurements using an electromagnetic flowmeter in a side channel in LMB1 2020; (e) RTK-GPS used to take points of channel bankfull edge and cross-sections in larger reaches (LMB2 in 2021).

The length of each river site surveyed was ten times the channel width before restoration. Channel geometry was surveyed with a real time kinematic (RTK) GPS or a total station (TS). For channels surveyed with a TS, we placed out ground control points (metal spikes) to be able to return and re-survey the same site and compare data between years. Channel banks were surveyed at bankfull (top of the banks) so as to be independent of water discharge, which may vary between surveys. The longitudinal profile was measured along the thalweg (deepest part of the channel). The thalweg was not surveyed for LMB1 and LMB2 due to high water levels restricting access. The morphology of five cross-sections at each site were measured using either the RTK-GPS, TS or an acoustic Doppler current profiler (ADCP) boat (Figure 2). The ADCP was pulled across the channel using a small raft, and measured the channel bed topography and velocities in a vertical profile along the entire transect. Because the ADCP can only be used when the depth is at least ~30 cm across the entire transect, it was only used at the two largest sites (LMB1 & LMB2) before restoration and at one of the sites 1 year post-restoration. At each cross-section, depth relative to bankfull and flow velocity were measured. Velocity was measured at 10 points across five cross-sections at 20 and 80% of the water depth, either using an electromagnetic flow meter or obtained from ADCP vertical velocity profiles (Figure 2). At the velocity measurement locations, three measurements were taken for 10 seconds each. The location, length and diameter of instream wood that exceeded 1 m in length and 0.1 m in average diameter were also measured with the RTK-GPS or TS.

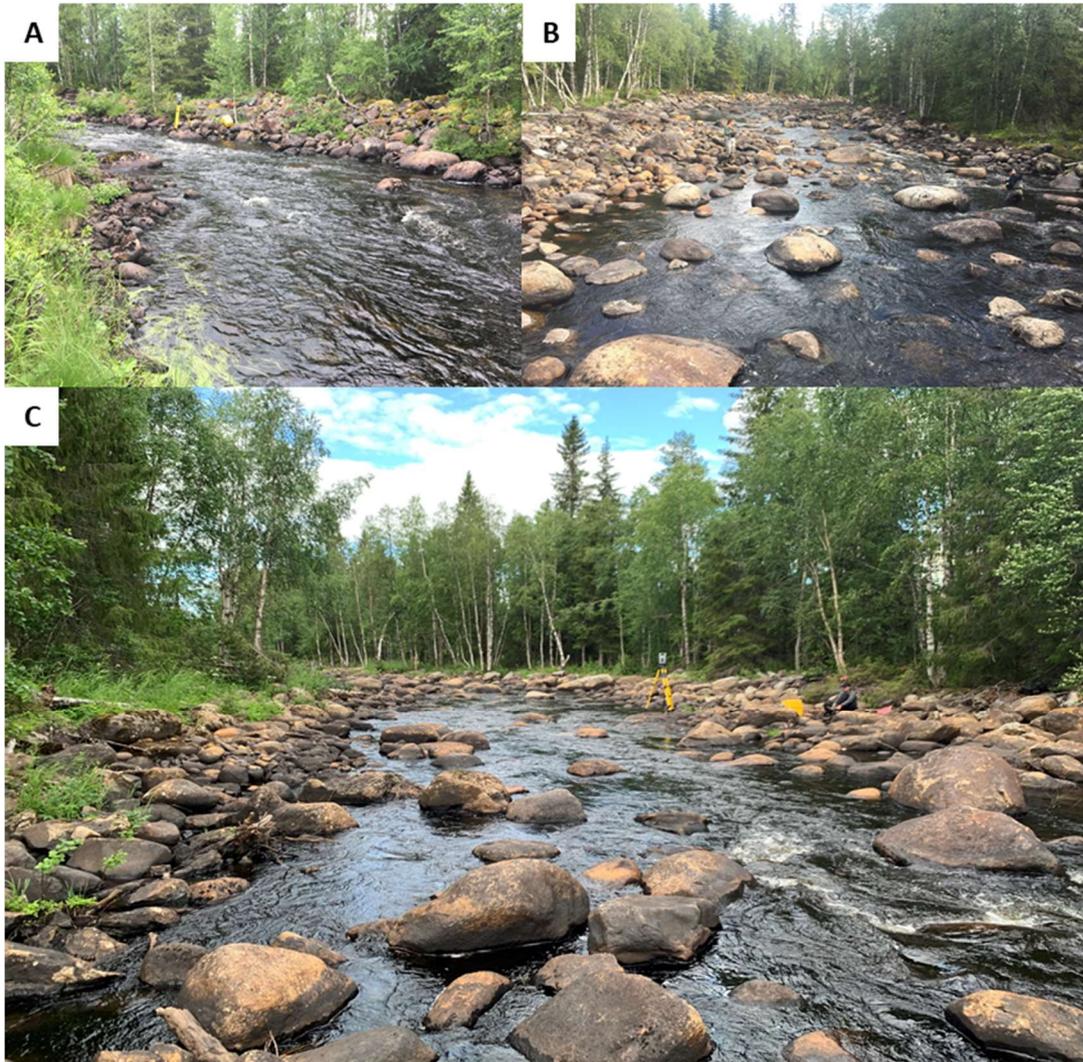
*Figure 4. LMA1 in each survey year. (A) Prior to restoration LMA1 was artificially narrowed and constrained by boulder levees. (B) following restoration (Post-A) these levees were removed and the channel width doubled (increase of 97% over Pre). (C) River width was maintained over the next 3 years (Post-B). At this site, therefore, restoration doubled the area of river habitat per unit river length.*

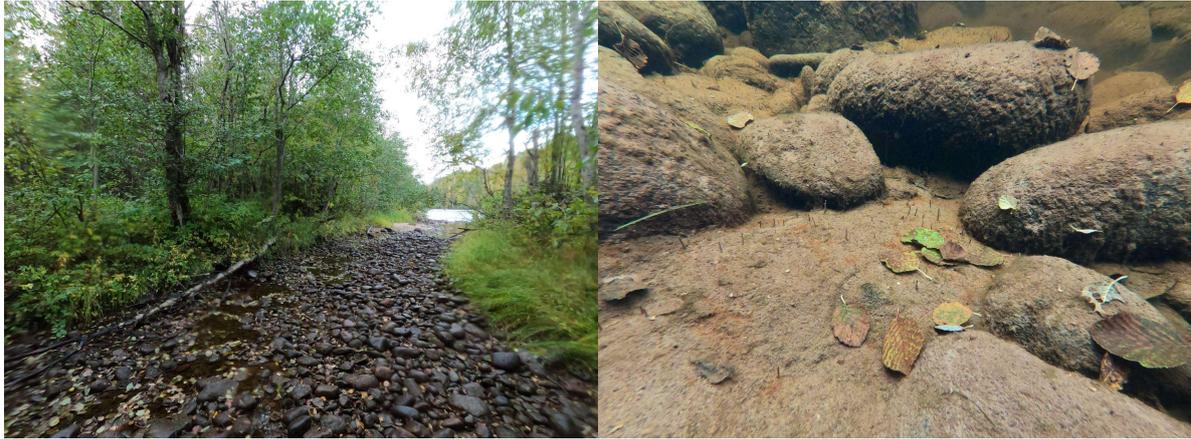
*Figure 10. Restoration of side channels (A) Side channel at LMB2 was dry during the survey in 2021. The lack of riparian vegetation indicates that the side channel is maintained at higher discharges and likely provides important ephemeral habitats and refugia. However, it is possible that over longer time periods the channel will become disconnected from the main channel again. (B) Fine sediment and organic material build up in side channels (also LMB2) shows that side channels are providing different habitats to the main channel (mostly clean scoured cobbles), increasing overall habitat heterogeneity within the site.*

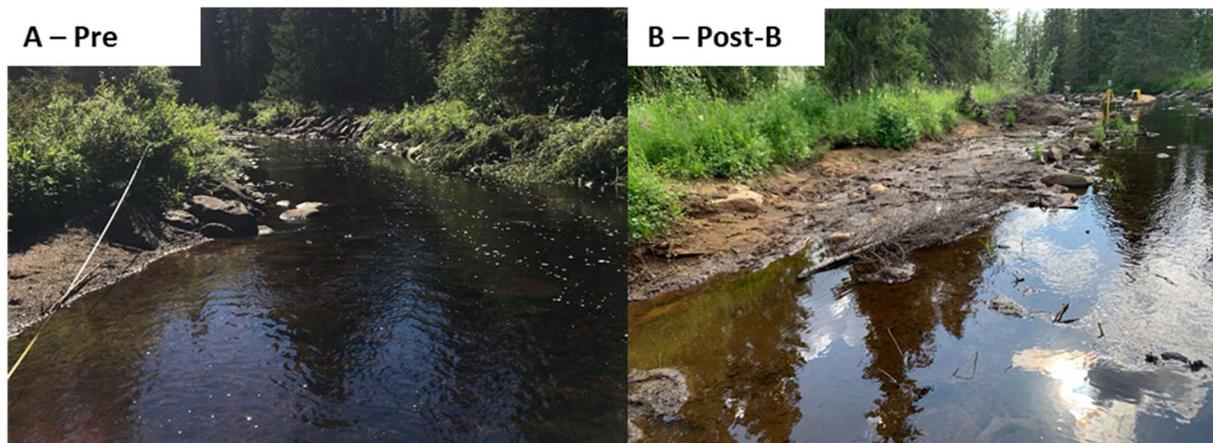
*Figure 11. LMA2 continued to erode following restoration. (i) looking downstream prior to restoration (ii) same location 3 years post restoration. New area of channel is the muddy area just above water level.*

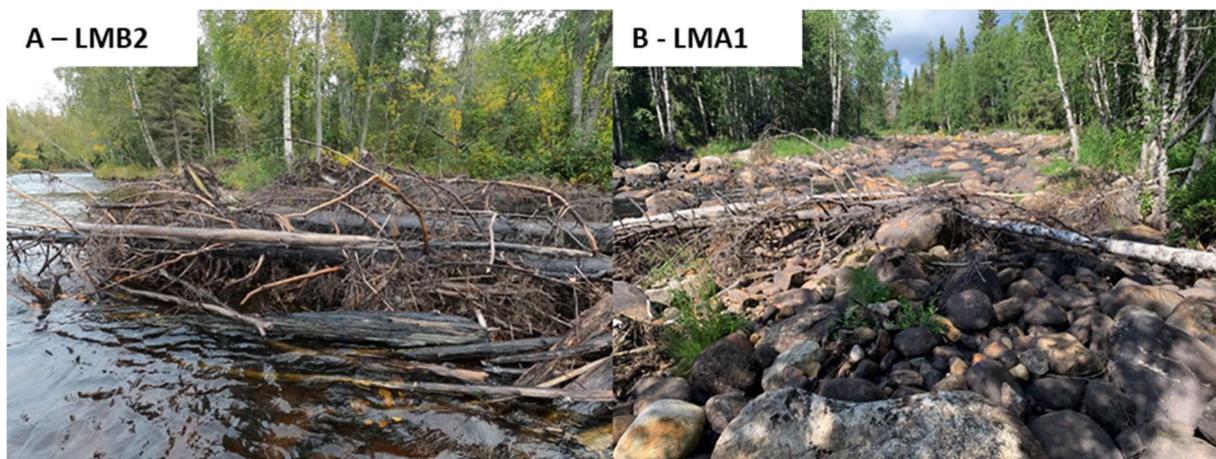
Figure 12. Examples of instream wood at two mainstem sites.

Woody material is an important natural part of river systems, both ecologically and geomorphologically. Wood addition during restoration was very variable between sites. Only a few sites had clusters of large wood but where present these are successful in trapping both sediment and smaller organic particles (e.g. timber chewed by beavers; Figure 12). Our measure of wood residency suggests that 32% of wood on average remained stable and the rest was transported post restoration. However, the wood only has to move marginally or there be some error in the operator surveys for the wood pieces not to overlap. Nevertheless, this suggests that much wood is mobile but wood volume and density show little change post restoration and therefore mobilised wood either is not transported out of the reach or is replaced by upstream wood.

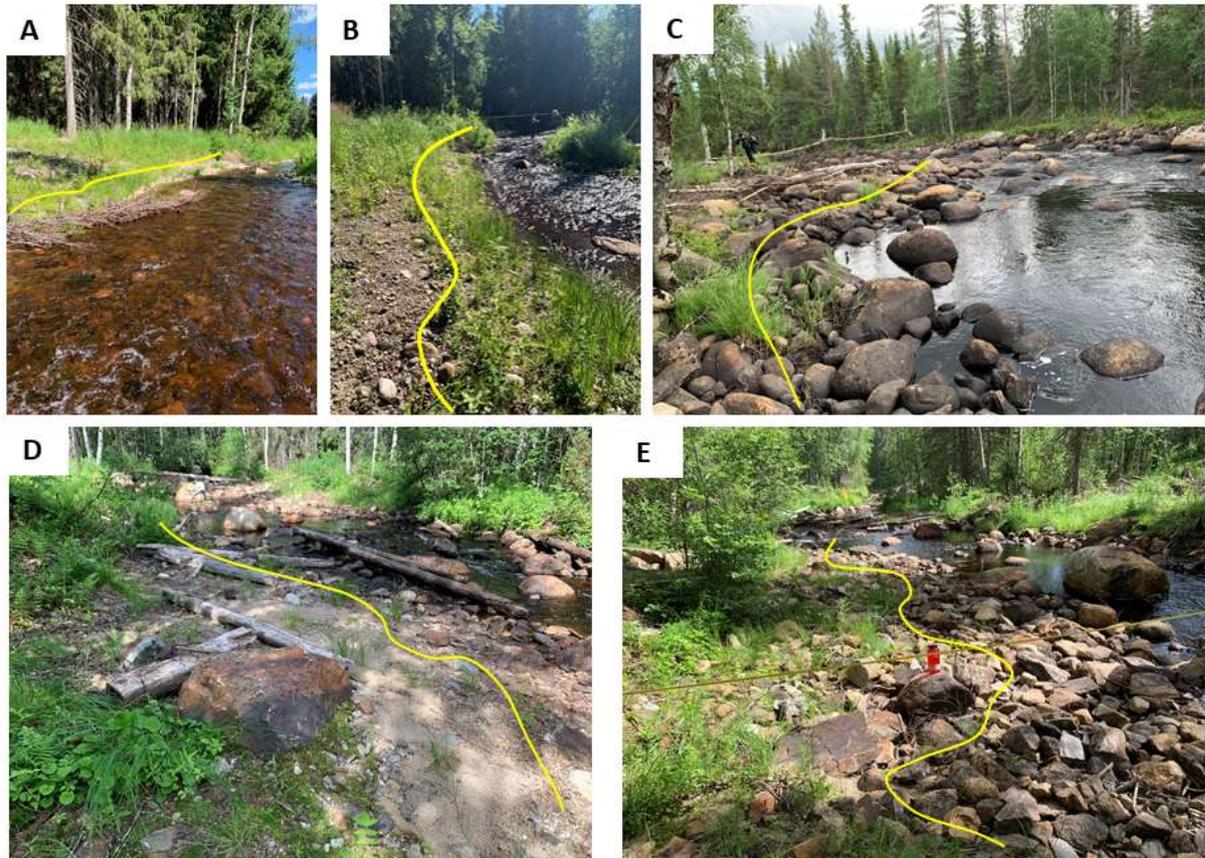
*Figure 13. Examples of inset bankfull forming in three years following restoration. Yellow lines show the newly formed bankfull which is below that formed during restoration. The formation of an inset bankfull indicates the potential for post-restoration adjustment of channel above and below the FHC; however, an inset bankfull can decrease channel-floodplain connectivity. Photos (a) & (b) are from LTB1 in 2021; (c) is from LMA1 in 2021 and photos (d) & (e) are from LTB2 in 2021.*
