# Monitoring of function of spawning sites within project ReBorN (LIFE15 NAT/SE/000892)

Sofia Perä and Patrik Olofsson

County Administrative Board of Norrbotten 2022

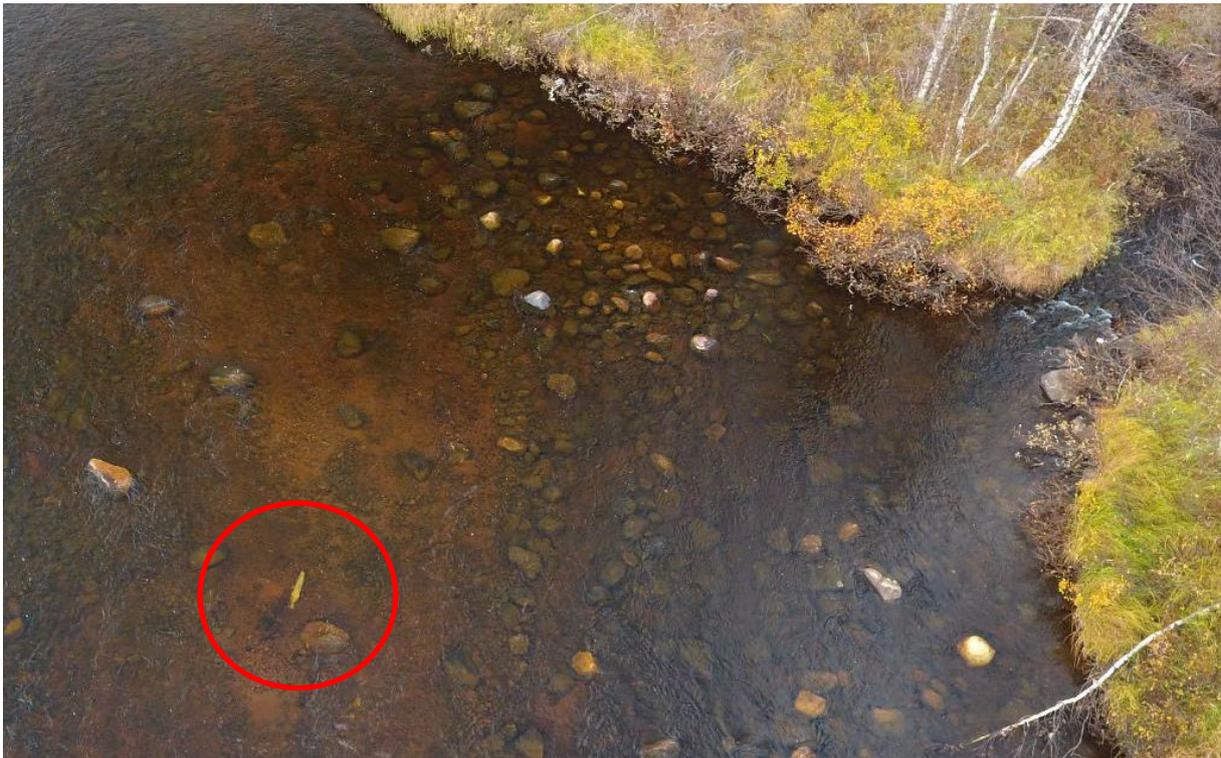
*Spawning salmon at a restored spawning area in river Linaälven, project area Kalixälven, 2018.*

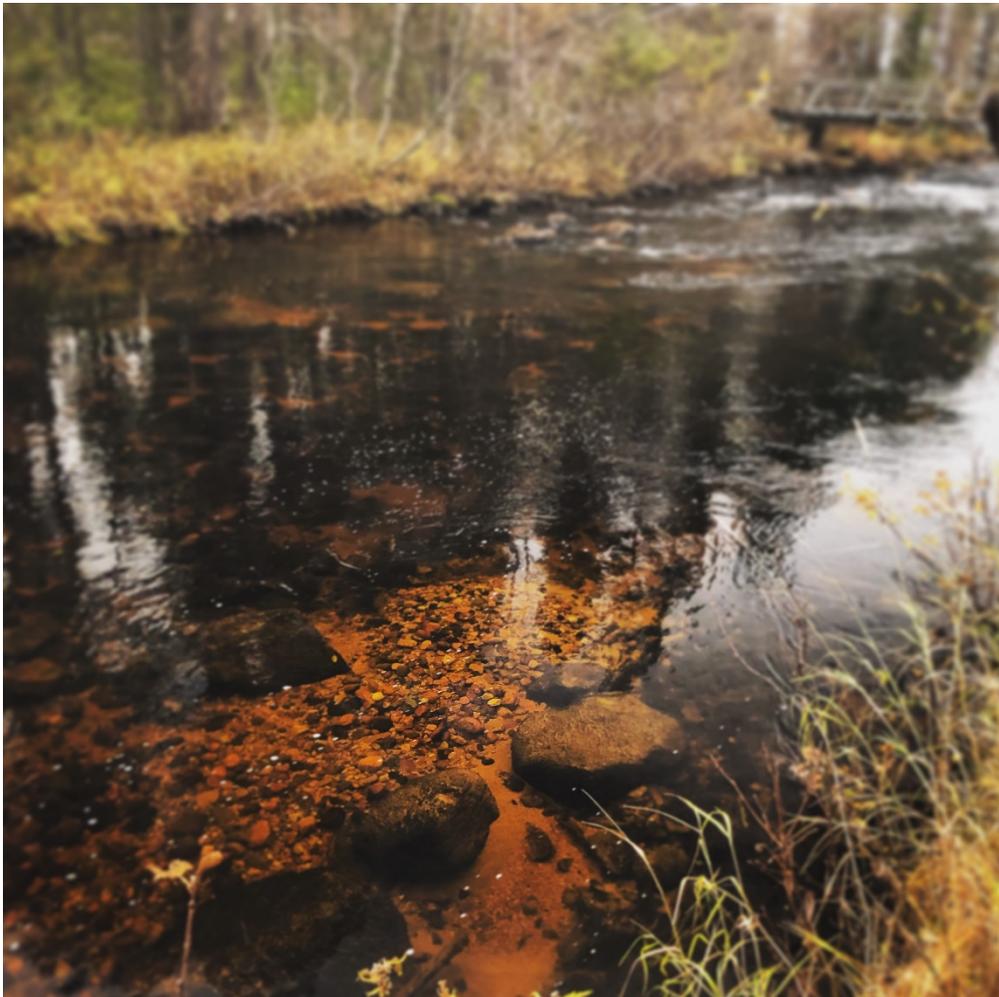
A spawning site (bed) is considered to be around 6 m<sup>2</sup> in size. In larger rivers huge spawning areas can be created and they can be as large as 2000 m<sup>2</sup>.

*Spawning bed. Right size of gravel and water velocity through the bed is essential for successful hatching.*

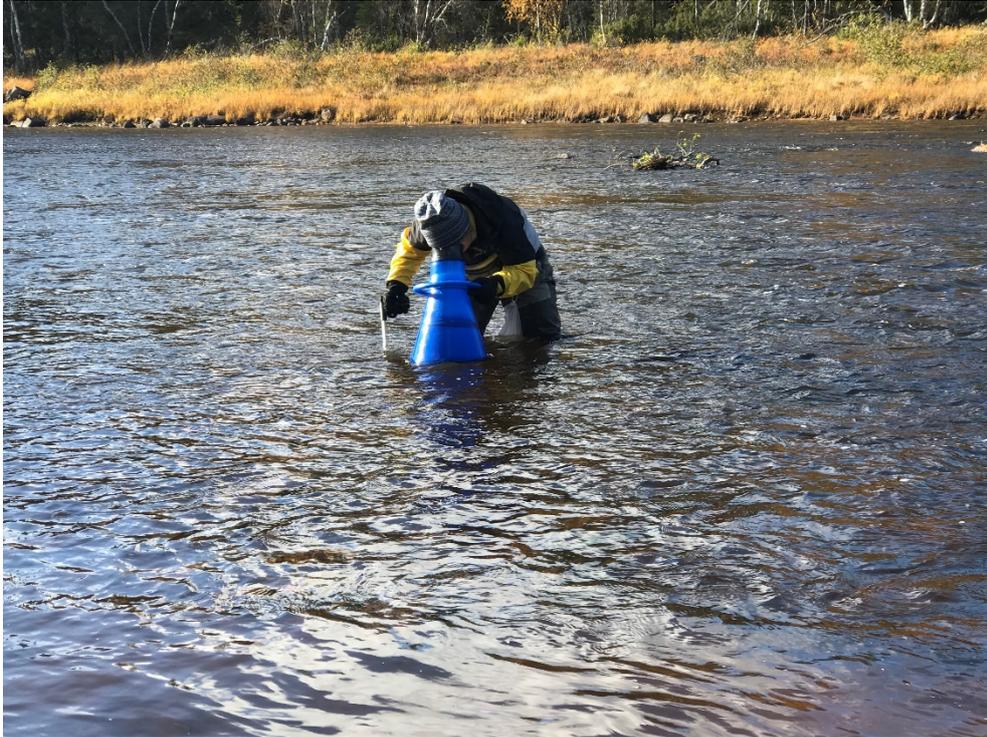
By using waders and bathyscope the created spawning sites are visually checked whether they have been used by salmon and/or trout. It is possible to see spawning fish at the sites if they are functional, and it is also possible to see tracks in the gravel from previously spawning fish (spawning pits). The action is done during September and October, which is the spawning time of salmon and trout.

*By using a bathyscope it is easier to see if the spawning bed has been used by fish.*

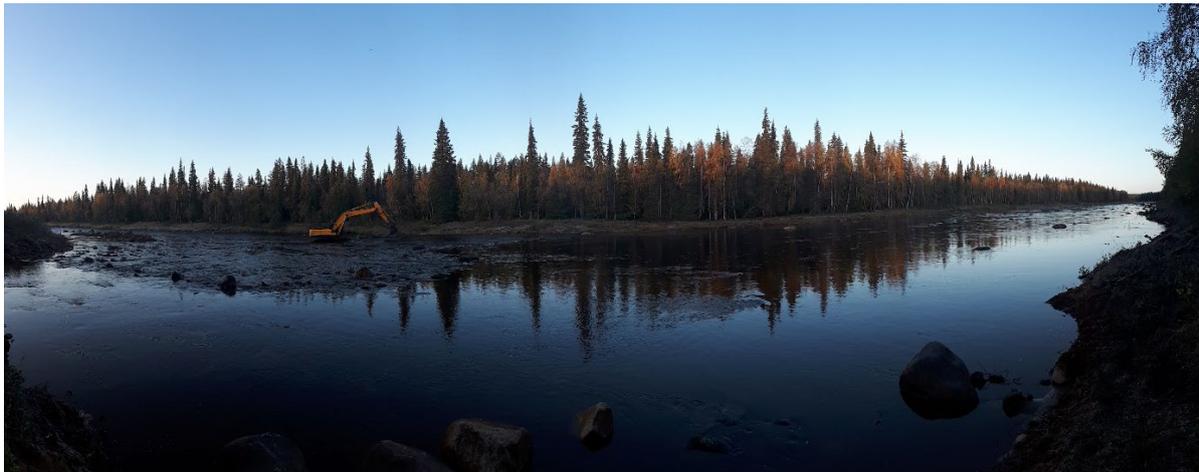
One of the objectives in the ReBorN project was to create 2300 spawning sites (6 m<sup>2</sup>). By the end of the project more than 14 000 spawning sites have been created. Smaller areas or single sites are mainly created or restored in small brooks. Larger areas that are made up of many sites are restored in larger rivers like the main channels of the rivers Råne-, Kalix- and Lögdeälven. These spawning areas can be as big as 2000 m<sup>2</sup> at some places where lots of gravel in the right sizes where found and other conditions where favorable. The spawning areas are usually located at the top of a rapid (river neck, where calm water pass over into a rapid).

*A large spawning area (~ 2000 m<sup>2</sup>) at Snasko in river Råneälven. It stretches from the river neck and 200 meters upstream.*

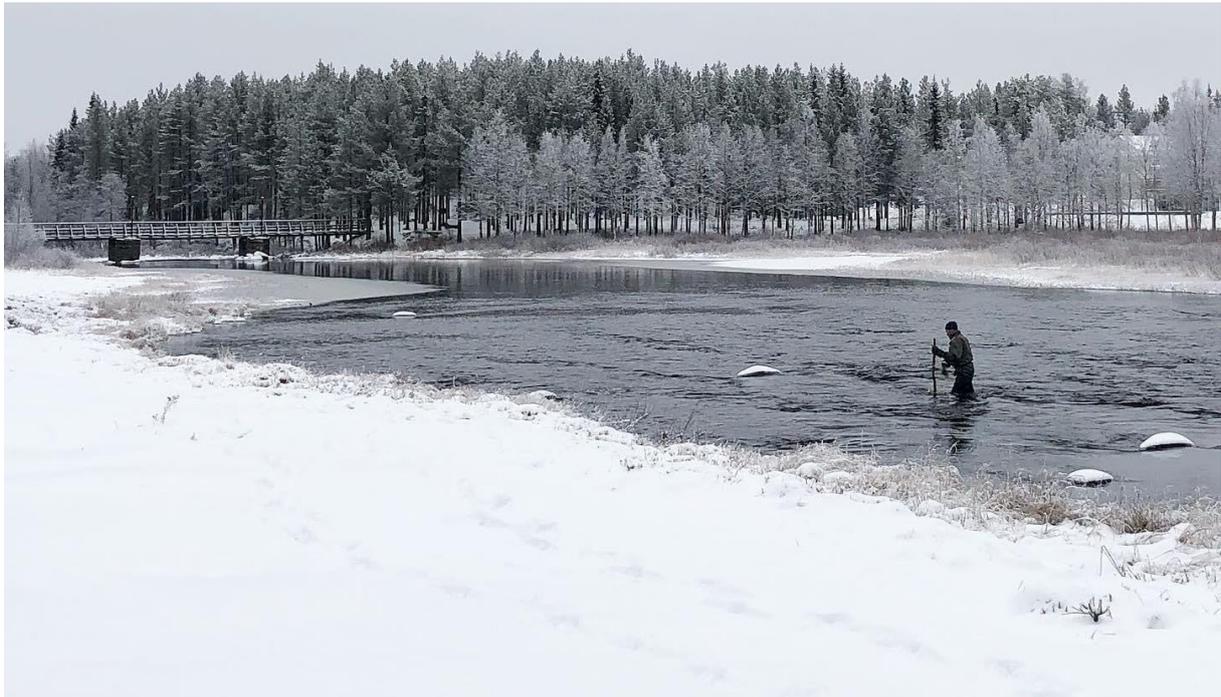
The monitoring in 2020 and 2021 was not complete due to a couple of different factors. In the County of Västerbotten there was very high water levels in the autumn, both 2020 and 2021 when the monitoring was taken place which made the monitoring difficult. In the County of Norrbotten it was snow and cold making the monitoring though.

*Monitoring of spawning area in river Vassaraälven, project area Kalixälven, in October 2020.*
