Monitoring of rewetted areas (action D5) within project
ReBorN in the county of Norrbotten
(LIFE15 NAT/SE/000892)

Dan Ojanlatva

County Administrative Board of Norrbotten 2022

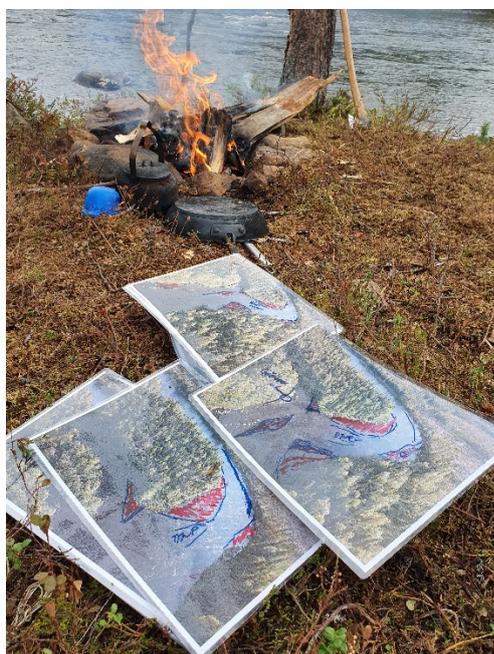
Picture 1. Råneälven 2020 planning for action.

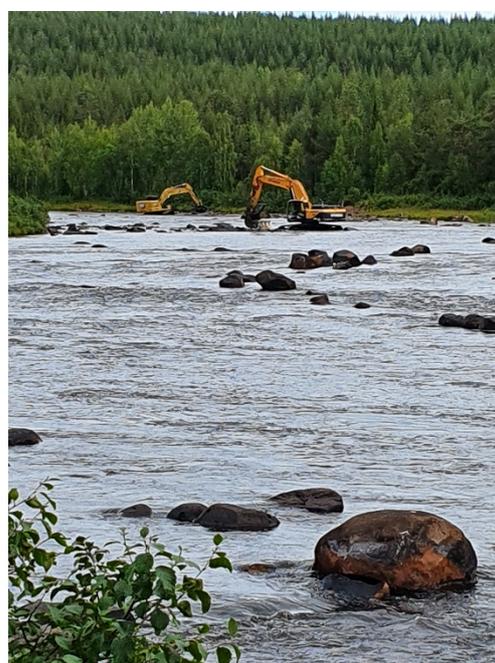
Picture 2. Råneälven 2020 executing plan,

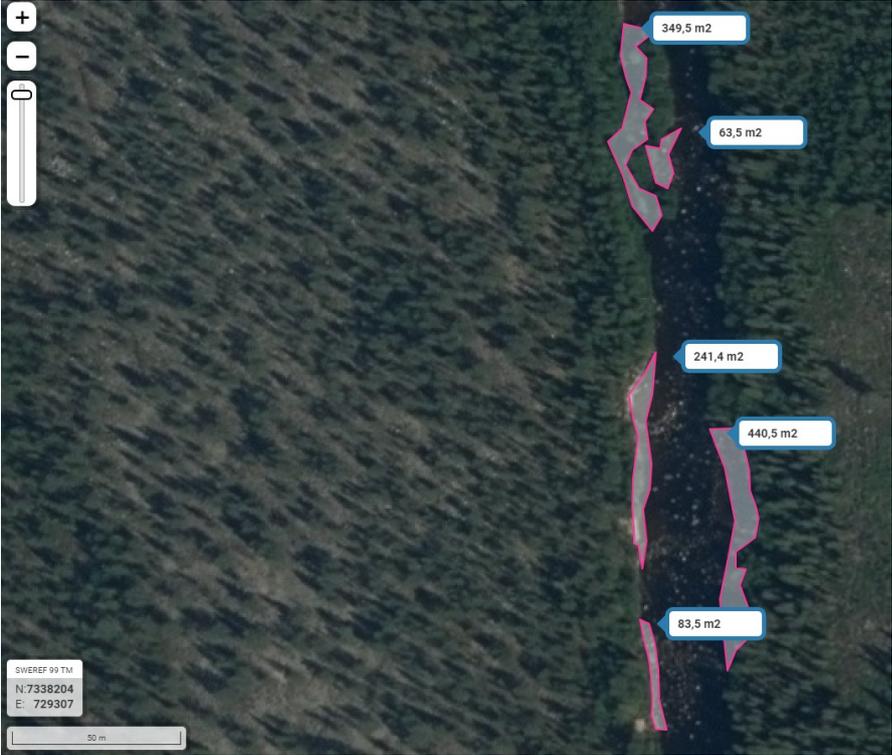
Picture 7. Orthographic picture after restoration @Lantmäteriet

LM orthographic photos are not equally high-resolution. The estimates are made by comparing older orthographic photos with newer ones. Orthographic pictures are not taken annually of the northern part of Sweden and the weather conditions can make the quality of the photos differ even if the photos are taken during the same period of the year, i.e. shading from tree canopy can differ a lot.
