Monitoring of rewetted areas (action D5) within project
ReBorN in the county of Västerbotten
(LIFE15 NAT/SE/000892)

County Administrative Board of Västerbotten 2022

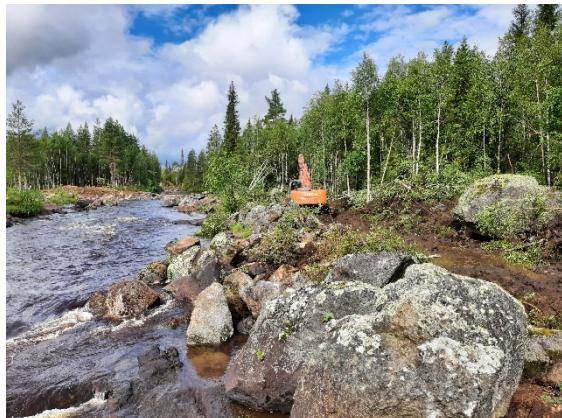
Picture 1. Lögdånn 2021 before / during restoration

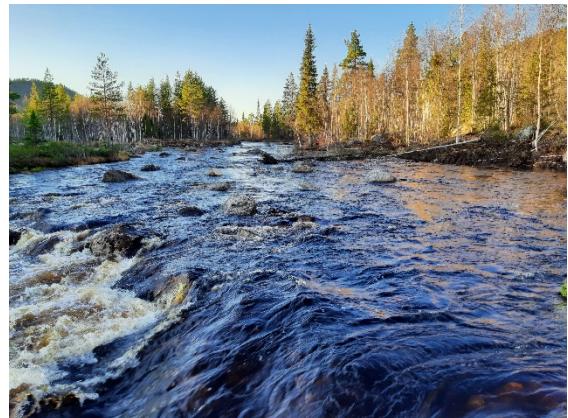
Picture 2. Lögdånn 2021 after restoration
